POSITION PAPER

Magnetic resonance imaging in individuals with cardiovascular implantable electronic devices

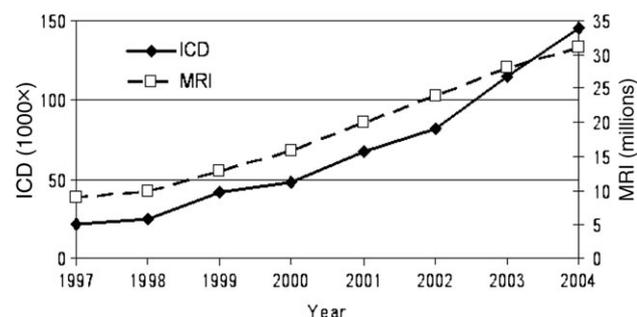
Figure 1 Number of annual magnetic resonance scans and of newly implanted implantable cardioverter-defibrillators in USA.

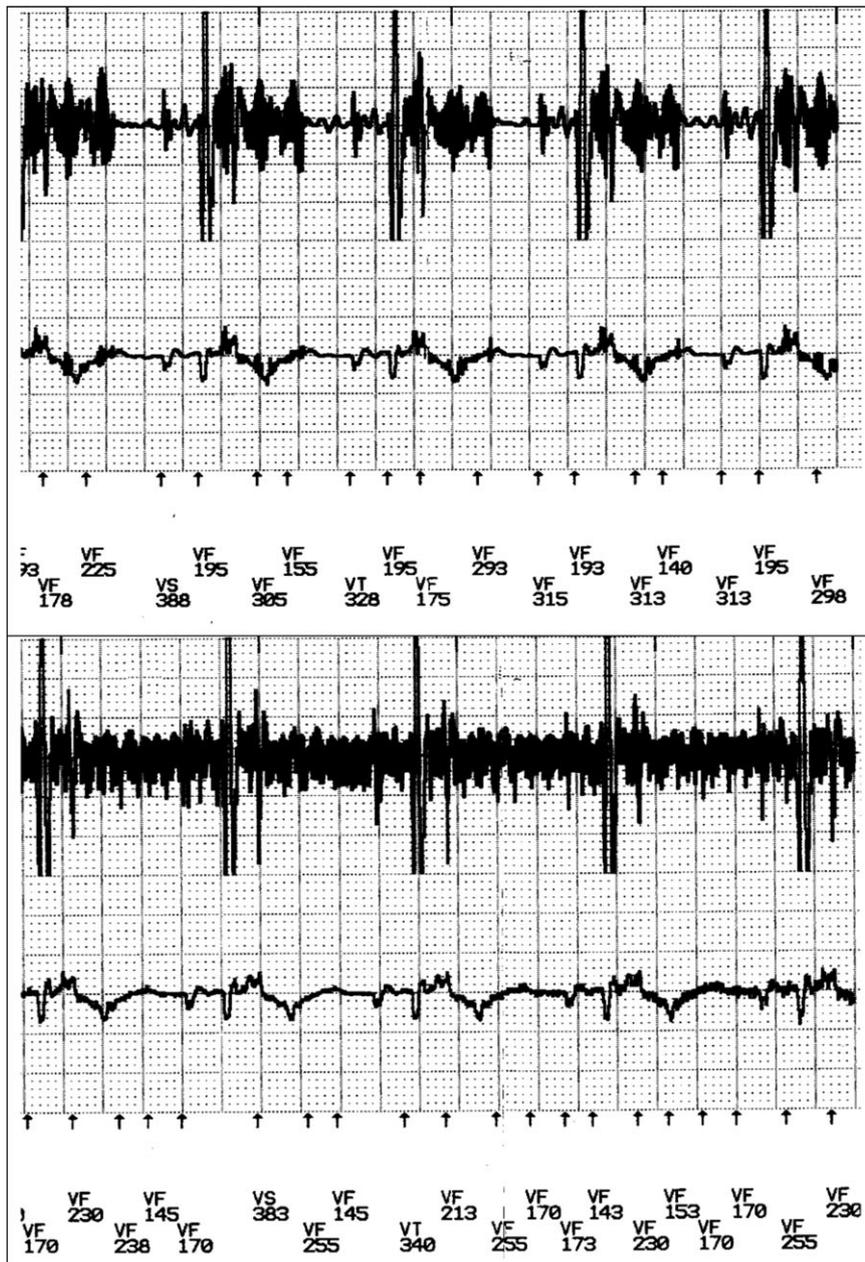
Figure 2 Magnetic resonance scan noise falsely detected by an ICD as ventricular fibrillation. (A) Magnetic resonance pulse (ECG-gated) sequence; (B) magnetic resonance continuous sequence.

ICD devices may falsely detect the MR RF field as ventricular tachyarrhythmia (*Figure 2*), charge capacitors, and subsequently deliver antitachycardia pacing, cardioversion or defibrillation therapies. In addition, magnetic fields may prevent detection of ventricular tachycardia or fibrillation. The heating problem of ICD leads can be expected to be comparable with that of pacemaker leads.^{27,29}
